Chapter 11

The Grotta degli Animali in the Garden of Villa di Castello in Firenze

Abstract The Grotta degli Animali, an artificial grotto located in the garden of Villa di Castello in Firenze, is a significant example of sixteenth-century Mannerist garden design. Commissioned by Cosimo I de' Medici, the grotto was designed by Niccolò Pericoli (Il Tribolo) and later completed by Giorgio Vasari, with contributions from renowned artists such as Jean de Boulogne (Gianbologna) and Ammannati. Featuring marble fountains and animal sculptures symbolizing natural elements, the grotto's hydraulic system once created the dramatic "Scherzo del Diluvio" water effect. Over the centuries, the grotto underwent multiple restorations, and recent work (completed in March 2024) utilized advanced digital documentation and 3D surveying techniques to reactivate the water features and improve its preservation. The project also integrated virtual reconstructions and addressed material degradation by creating a monitoring system for the grotto's microclimate and structural health. Diagnostic surveys and advanced surveying methods, including laser scanning and photogrammetry, revealed key structural challe

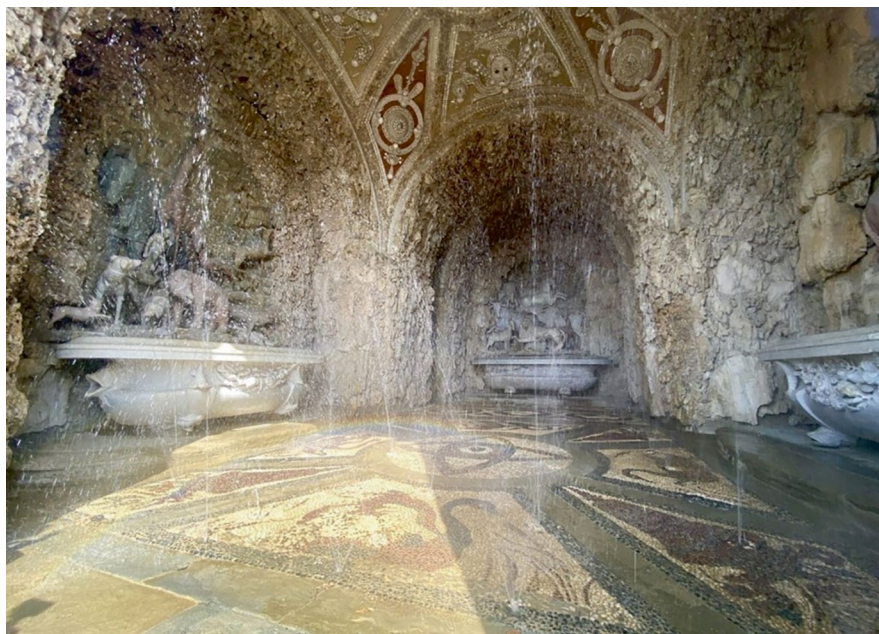
Fig. 11.1 Villa di Castello (Firenze), view of the interior of the Grotta degli Animali after the water supply system reactivation

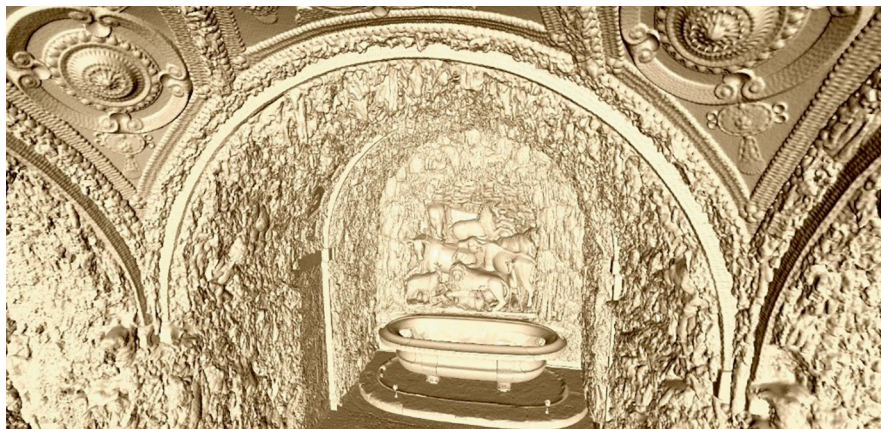
Fig. 11.2 Mesh model, view of the front tank

In parallel, the survey of the extrados and lead pipes was carried out during the excavation campaign, with initial acquisitions in 2013 and further checks in 2015. Thanks to the three-dimensional model, it was possible to conduct analyses that would not have been feasible with only two-dimensional representations, correlating the pipes of the extrados with the internal pockets of the cave, which are essential for activating the “Diluvio” effect. Additionally, a close-range photogrammetry campaign thoroughly documented the pipe system, allowing for the analysis of the various components of the hydraulic system, including water supply and distribution.

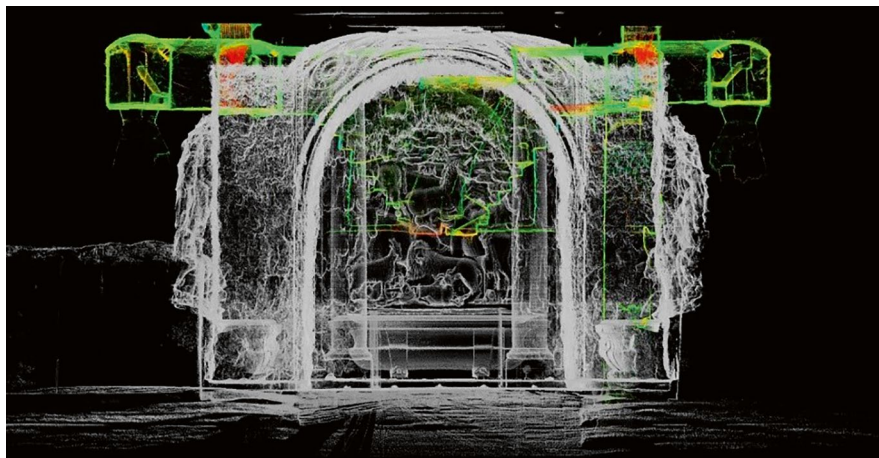
Fig. 11.3 Image of the point cloud model as of September 2018, showing the grotto and the perimeter conduits of the second level

point cloud model (Fig. 11.3) facilitated an understanding of the relationship between the internal and external spaces of the entire architectural complex. Further investigations revealed additional conduits and currently inaccessible spaces, which are believed to correspond to a second level of tunnels above the two side branches leading to the lateral nymphaea of the grotto. The survey of the trees also allowed for an analysis of how the roots impact the ground and, in turn, the conduits, which in some cases are directly affected by the root system, compromising their structural integrity.

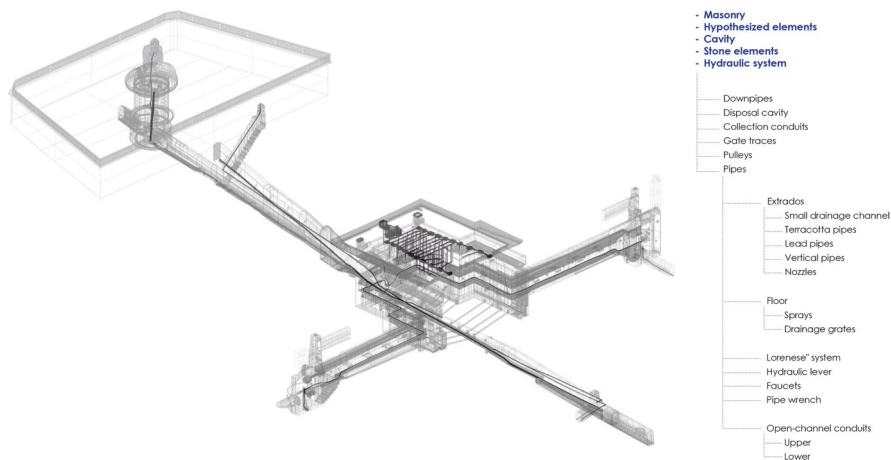
Fig. 11.4 Overview of the surface model highlighting the decomposition of the hydraulic system layers

Based on the data collected during the various survey campaigns of the grotto and the surrounding conduit system, a simplified model was developed using NURBS surfaces, which was subsequently divided into a hierarchy of elements identified within the conduits (Fig. 11.4). The 3D surface model was initially broken down into macro-elements, starting with the broader context, which includes the surrounding terrain and the retaining walls of the Grotta degli Animali, before moving on to the various conduits that encircle it. A further breakdown was then carried out, focusing on the main masonry structures, secondary conduits, vertical conduits communicating with the exterior, supporting walls for the open-air conduits,

The simplification of the modeling process has made it easier to understand the complex hydraulic system, which would otherwise be difficult to interpret due to fragmented historical sources and hard-to-access survey data. This model helps restorers plan interventions with precision, reducing the risk of unnecessary or excessive actions that could compromise the site. Additionally, the model holds great communicative value, allowing visitors to visualize and understand the hidden conduits and how water was channeled to create spectacular visual effects. Beyond serving as an educational and engaging tool, it could also serve as the foundation for a digital twin of the hydraulic system, useful not only for monitoring its conservation against environmental risks but also for gathering and preserving the historical and technical data accumulated over time.

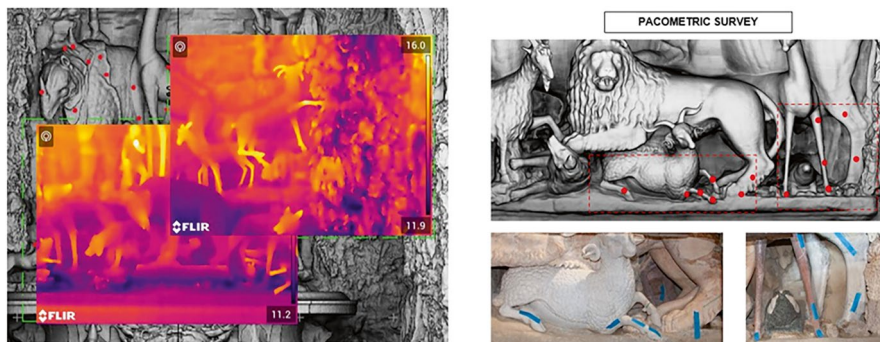
Fig. 11.6 (a) Thermal survey performed on the sculptures; (b) internal reinforcement elements detected by the pacometric measurements

A measurement campaign by non-destructive techniques was also performed to detect differences in heat emitting and possible areas of moisture retention (Fig. 11.6a), to localize the metal supports of the animals' sculptures and the walls of the grotto, and to assess the rate of biological growth. For the above targets the InfraRed Thermography (IRT), Pacometric Surveys and bioluminometer (for the Adenosine Triphosphate detection) were employed. In particular, the thermal survey was also performed for monitoring by thermal images the different surfaces' drying time after water spraying. Due to the water run-off on the stone sculptures' surface, the occurrence of corrosion phenomena had to be considered since the

presence of internal reinforcement consisting of iron pins and iron brackets. To achieve this aim, a pacometric survey was performed exploiting the principle of the magnetic field absorption measurement to locate the metal elements and their state of conservation (the diameter of the pin can be estimated). On Fig. 11.6b, the map of the detected pins (\varnothing 8–16 mm) and brackets, is shown. Their presence is mainly due to the previous interventions for the consolidation, strengthening, and replacement of damaged parts (more fragile parts, such as the animals' paws, the animals' ears). Moreover, the grouts and mortars used for filling the fractures and junctions among different parts will be monitored to prevent water infiltrations and corrosion risk.

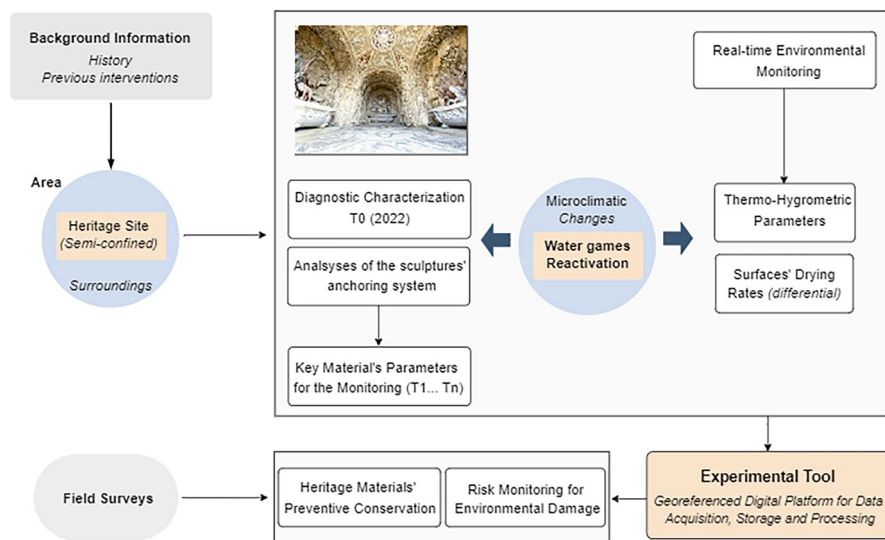
Fig. 11.7 Overview of the methodological approach leading to the development of the Risk Monitoring Tool for Cultural Heritage in semi-confined environments exposed to microclimate changes

The above results will be completed with radiometric data captured on the wetted surface by IR thermography camera. The spot temperature measure is useful to calibrate the radiometric image to obtain information on the drying dynamics of the surface. Continuous thermal monitoring will be provided by the integration of the thermal sensors within the environmental monitoring system (see Chap. 14). This will allow to better investigate the critical aspects, such as areas subjected to water stagnation or subjected to mechanical damage for the impact of falling water (Fig. 11.7).

In conclusion, the monitoring strategy focuses on the correlation of selected parameters, investigated before the water games are switched on, during and after their switch-off, to determine the cyclic variation of the micro-climate conditions inside the grotto; moreover, different drying rates of the stone surfaces will be considered, to detect vulnerabilities and preventive conservation interventions.
